Manhole Inspection Summary

Manhole # S41W__038MH

Inspection ☐ Is Incomplete Rating: **3) Fair**

Insp Date: **10/10/08 1:04 PM**

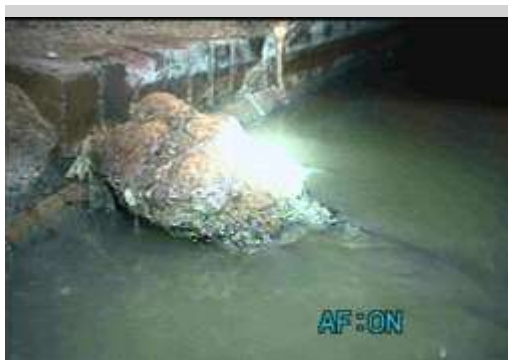
Defect 4

Condition: ☐ Sound ☐ Cracked ☐ Root Intrusion ☐ Deteriorated ☐ Leaks ☒ **Debris**

channel debris

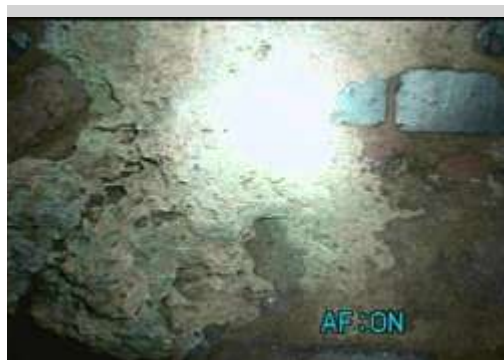
Defect 3

Condition: ☐ Sound ☐ Cracked ☐ Root Intrusion ☐ Deteriorated ☐ Leaks ☒ **Debris**

bench debris

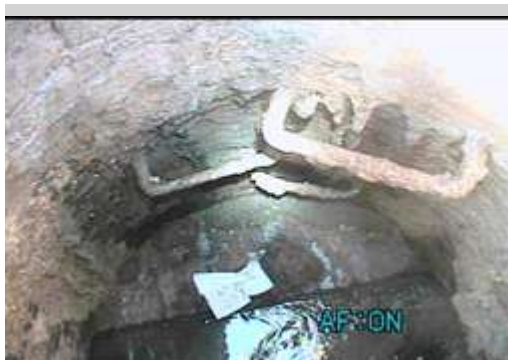
Defect 2

Infiltration: ☐ None ☐ Joint ☐ Cracks ☐ Mortar ☐ Roots ☒ **Wall**

Count: **3** Missing: **0** ☒ **Corroded**

corroded steps, extreme infiltration from chimney joint & wall

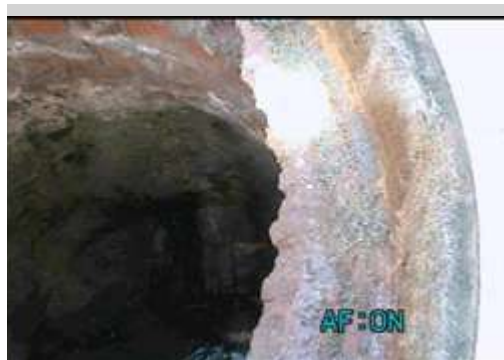
Defect 5

Offset: **3** (in.)

offset

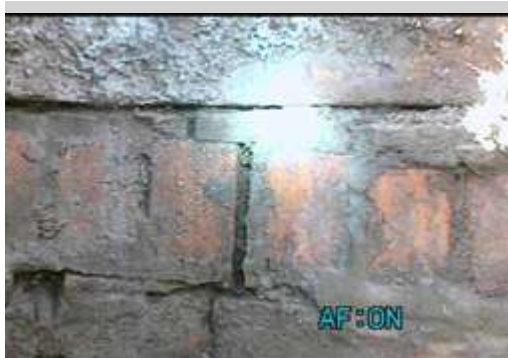
Defect 1

Condition: ☐ Sound ☒ **Cracked** ☐ Root Intrusion ☐ Loose Brick ☐ Deteriorated

cracked chimney/frame adj, chimney infiltration

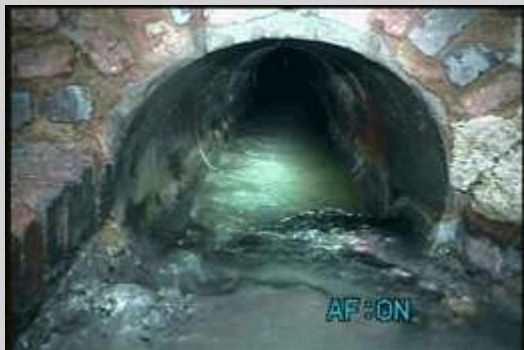
12 O'Clock Outflow

18 in. Circular Gravity Sewer
Pipe Out @ 12 O'Clock

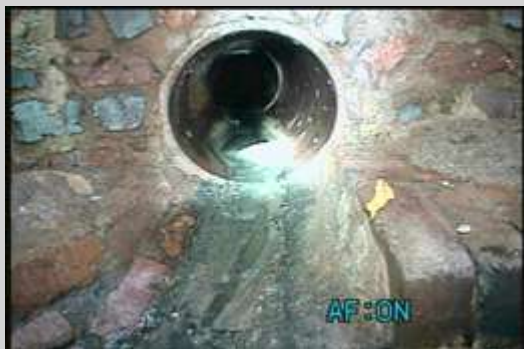
3 O'Clock Inflow

8 in. Circular Gravity Sewer
Pipe In @ 3 O'Clock

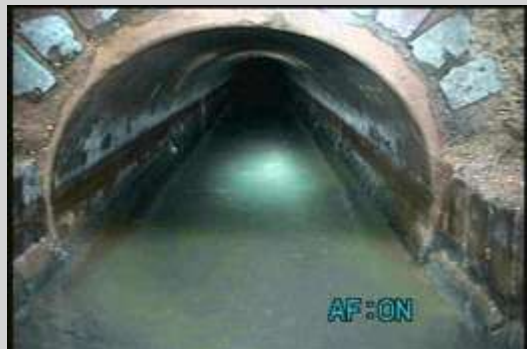
6 O'Clock Inflow

18 in. Circular Gravity Sewer
Pipe In @ 6 O'Clock
